The Stability of the Victorian Clay Railway Embankment in Grange Park, London N21

The Effects of Tree Felling and Vegetation Removal

**By Peter Johns
On Behalf of The N21 Rail Action Group**

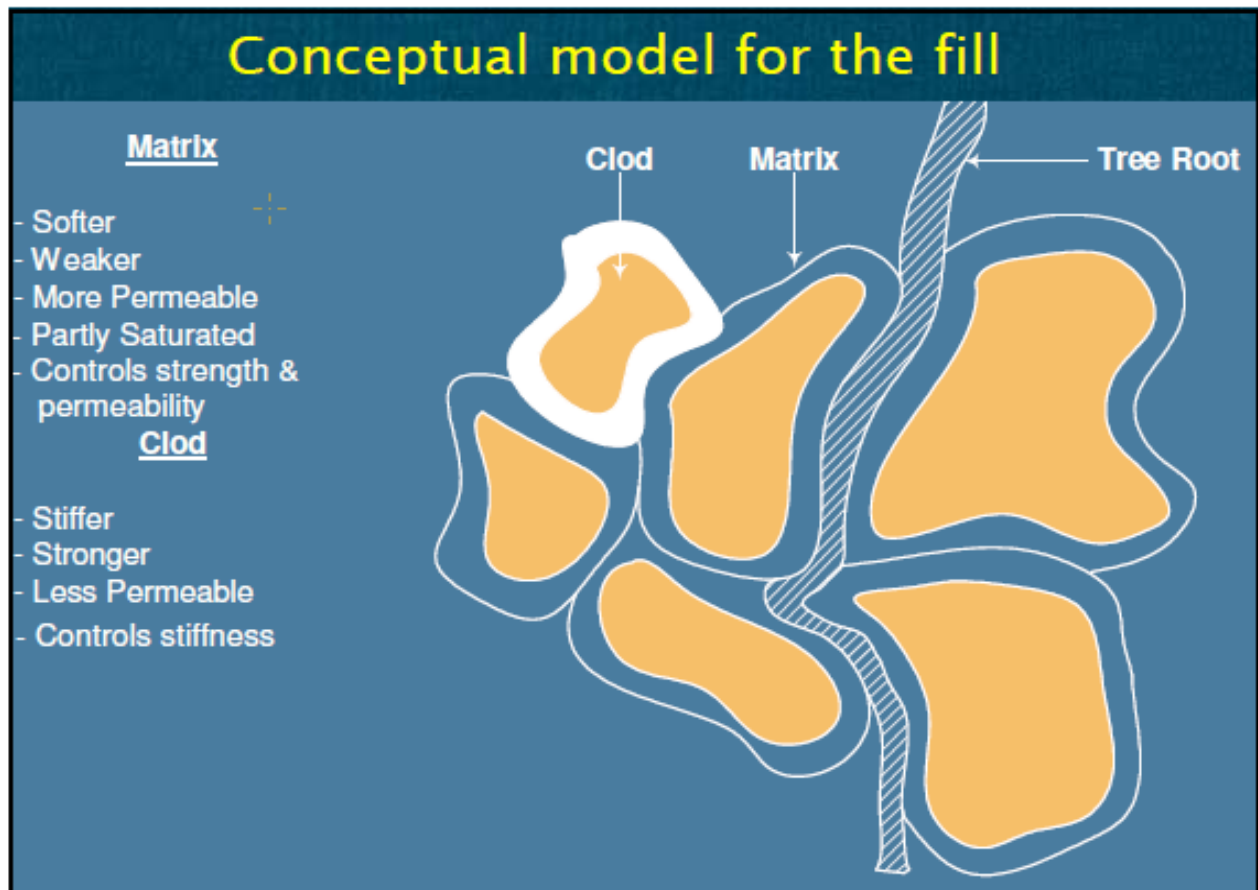
Figure 1

The railway embankments found in Grange Park were formed by end tipping hand excavated clay spits or clods (a spit is an undisturbed lump of clay cut by a small spade used in this type of excavation) and compacted using those resources available in late Victorian times. The result was an embankment that was not very well compacted. (fig.1)

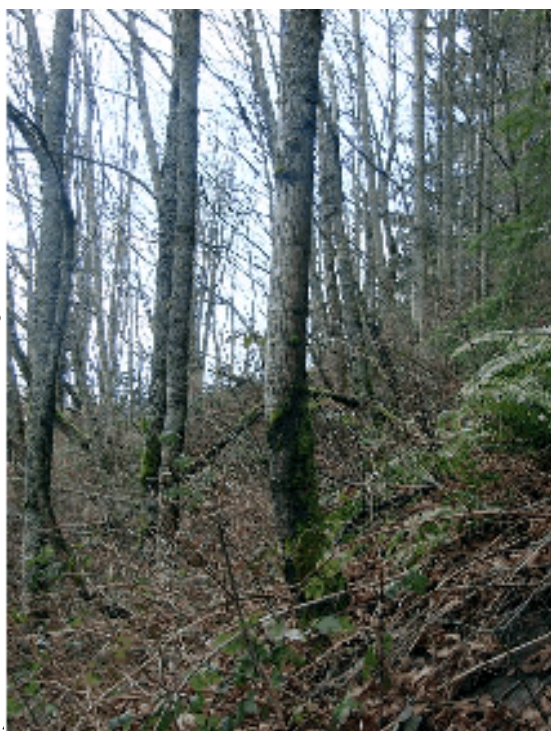
As there is only one cycle per year it takes many years before this loss of strength starts to be noticed. Unstable slopes are indicated by the growth pattern of trees. Trees on a stable slope grow vertically but on a slope that is slowly creeping the trunks develop curvature. (fig 2)

Figure 2
Deformed tree growth as a result of hillside creep.

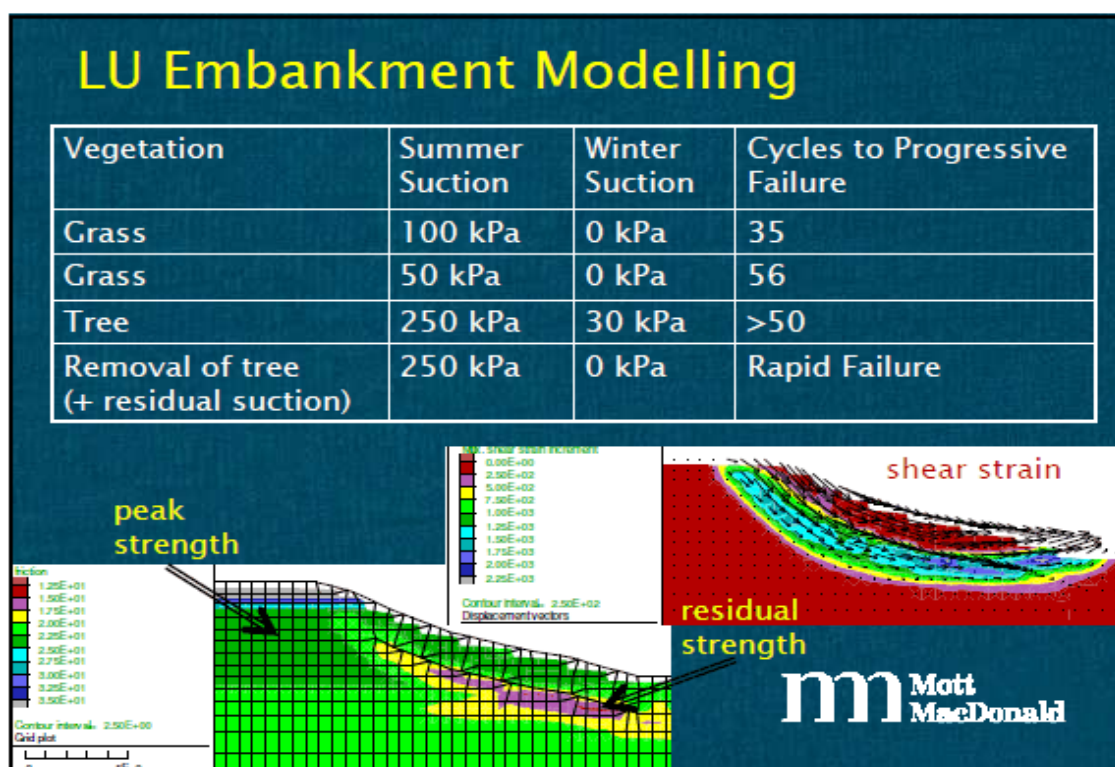
Figure 3

But the most alarming fact emerging from this study was that, in embankment modelling work carried out for London Underground, the loss of soil suction associated with the **complete** removal of trees rapidly leads to embankment failure. (fig. 3)

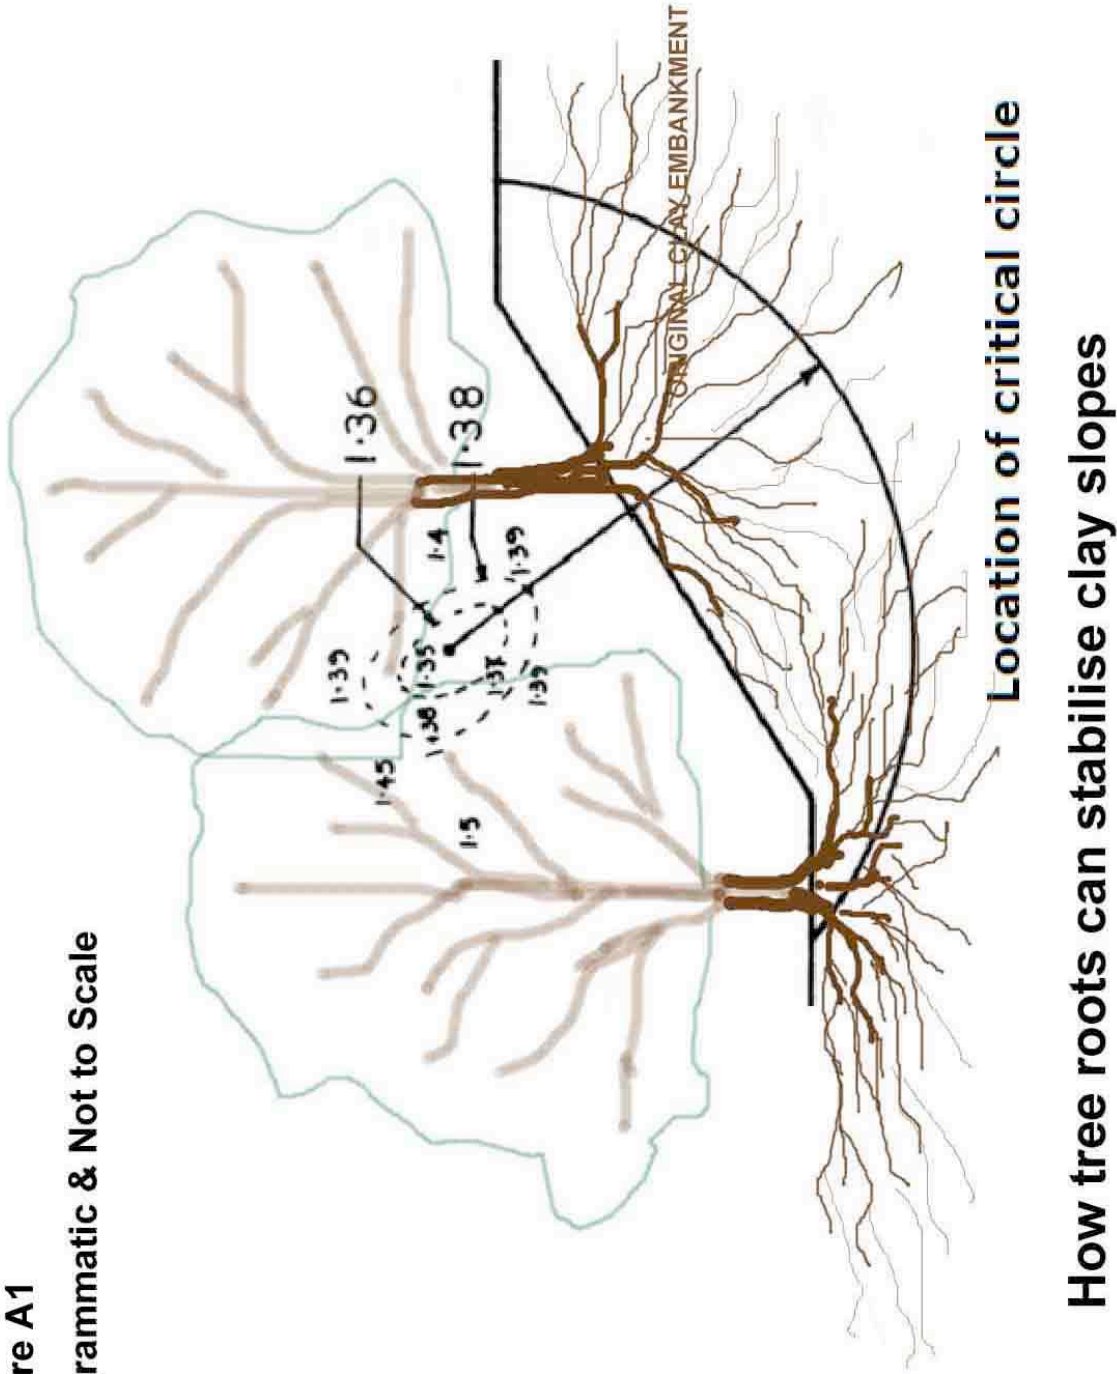
Gabions (i.e. rock filled wire baskets forming a mass retaining wall) are again often used but once again they will not control moisture entering the clay. A further problem with using gabions is providing a good foundation at the toe of the embankment in a region of potential failure (see Appendix A figs A1 & A2)

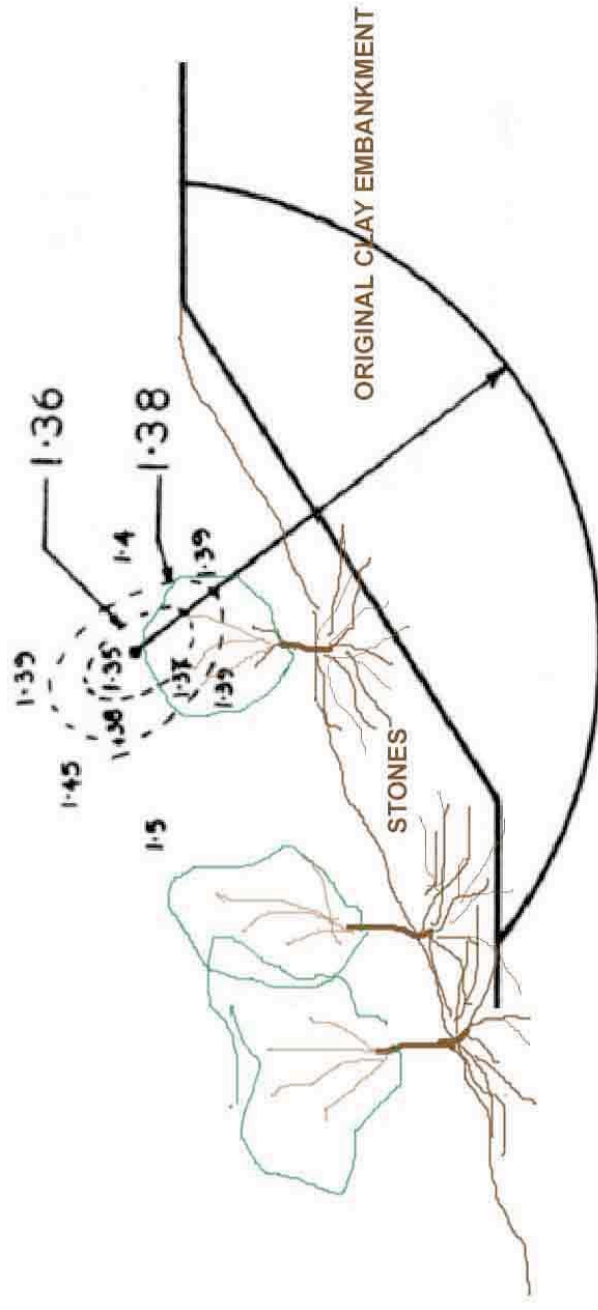
Figure A2
Diagrammatic & Not to Scale

Location of critical circle

Note the lack of roots now anchoring the potential slip surface within the embankment
