ROAD SAFETY AUDIT RESPONSE

Endymion Road/Alroy Road Pedestrian Safety Measures - RSA STAGE 1/2

25/11/14

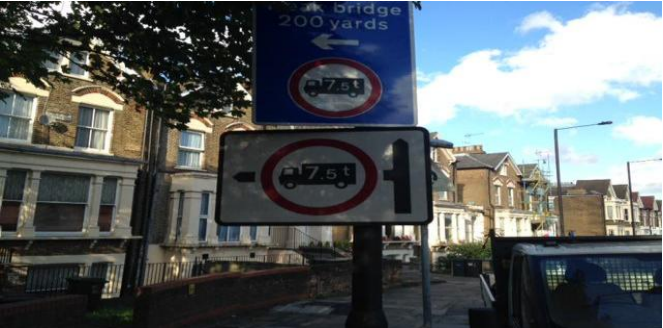
<p>2.5.1 PROBLEM:</p> <p>Location J: Northeast approach bound to the junction - Drawing 003.</p> <p>Summary: Inappropriate signage could compromise road safety.</p> <p>Detail: On the northeast bound approach to the mini-roundabout junction there is an</p>	<p>Agreed – Signage will be replaced.</p>

<p>advanced direction sign, indicating a priority junction with the northeast bound movement having priority (see figure 1 below), where a 'Roundabout Ahead' sign immediately follows; however, this sign is very faded and in poor condition. There is concern that traffic on this approach could be misled and this could lead to side impact or rear end shunt accidents.</p>

<p>RECOMMENDATION: That both signs should be replaced with appropriate signage</p>		
<p>2.5.2 PROBLEM: Location K: Mini-roundabout junction - Drawing 003. Summary: Insufficient signage could compromise road safety. Detail: Currently, there is no 'Mini-roundabout' signage on the northeast bound approach to the junction, nor is such a sign proposed as part of the works. Traffic on this approach is insufficiently warned that right turning traffic has priority at the junction, which could lead to side impact accidents, particularly during conditions of poor visibility when the road marking may be less visible. RECOMMENDATION: That a 'Mini-roundabout' sign to diagram 611.1 should be installed at the junction for northeast bound traffic.</p>	<p>Agreed – Correct signage will be installed.</p>
