Road Safety Audit Combined Stage 1/2

Alroy Road / Endymion Road, Cycling Facilities Improvement Scheme

London Borough of Haringey

October 2014

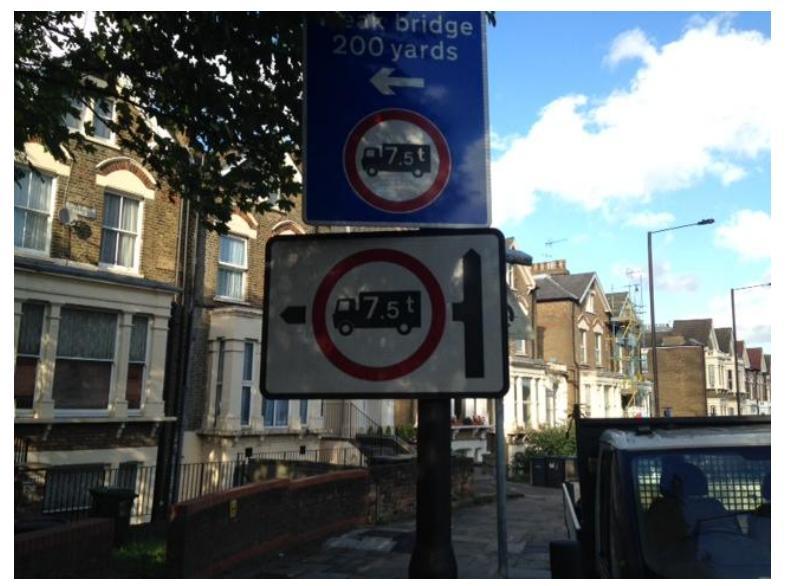
Location J: Northeast approach bound to the junction - Drawing 003.

Detail: On the northeast bound approach to the mini-roundabout junction there is an advanced direction sign, indicating a priority junction with the northeast bound movement having priority (see figure 1 below), where a 'Roundabout Ahead' sign immediately follows; however, this sign is very faded and in poor condition. There is concern that traffic on this approach could be misled and this could lead to side impact or rear end shunt accidents.

Figure 1: Inappropriate signage in advance of the mini-roundabout junction.

That both signs should be replaced with appropriate signage.

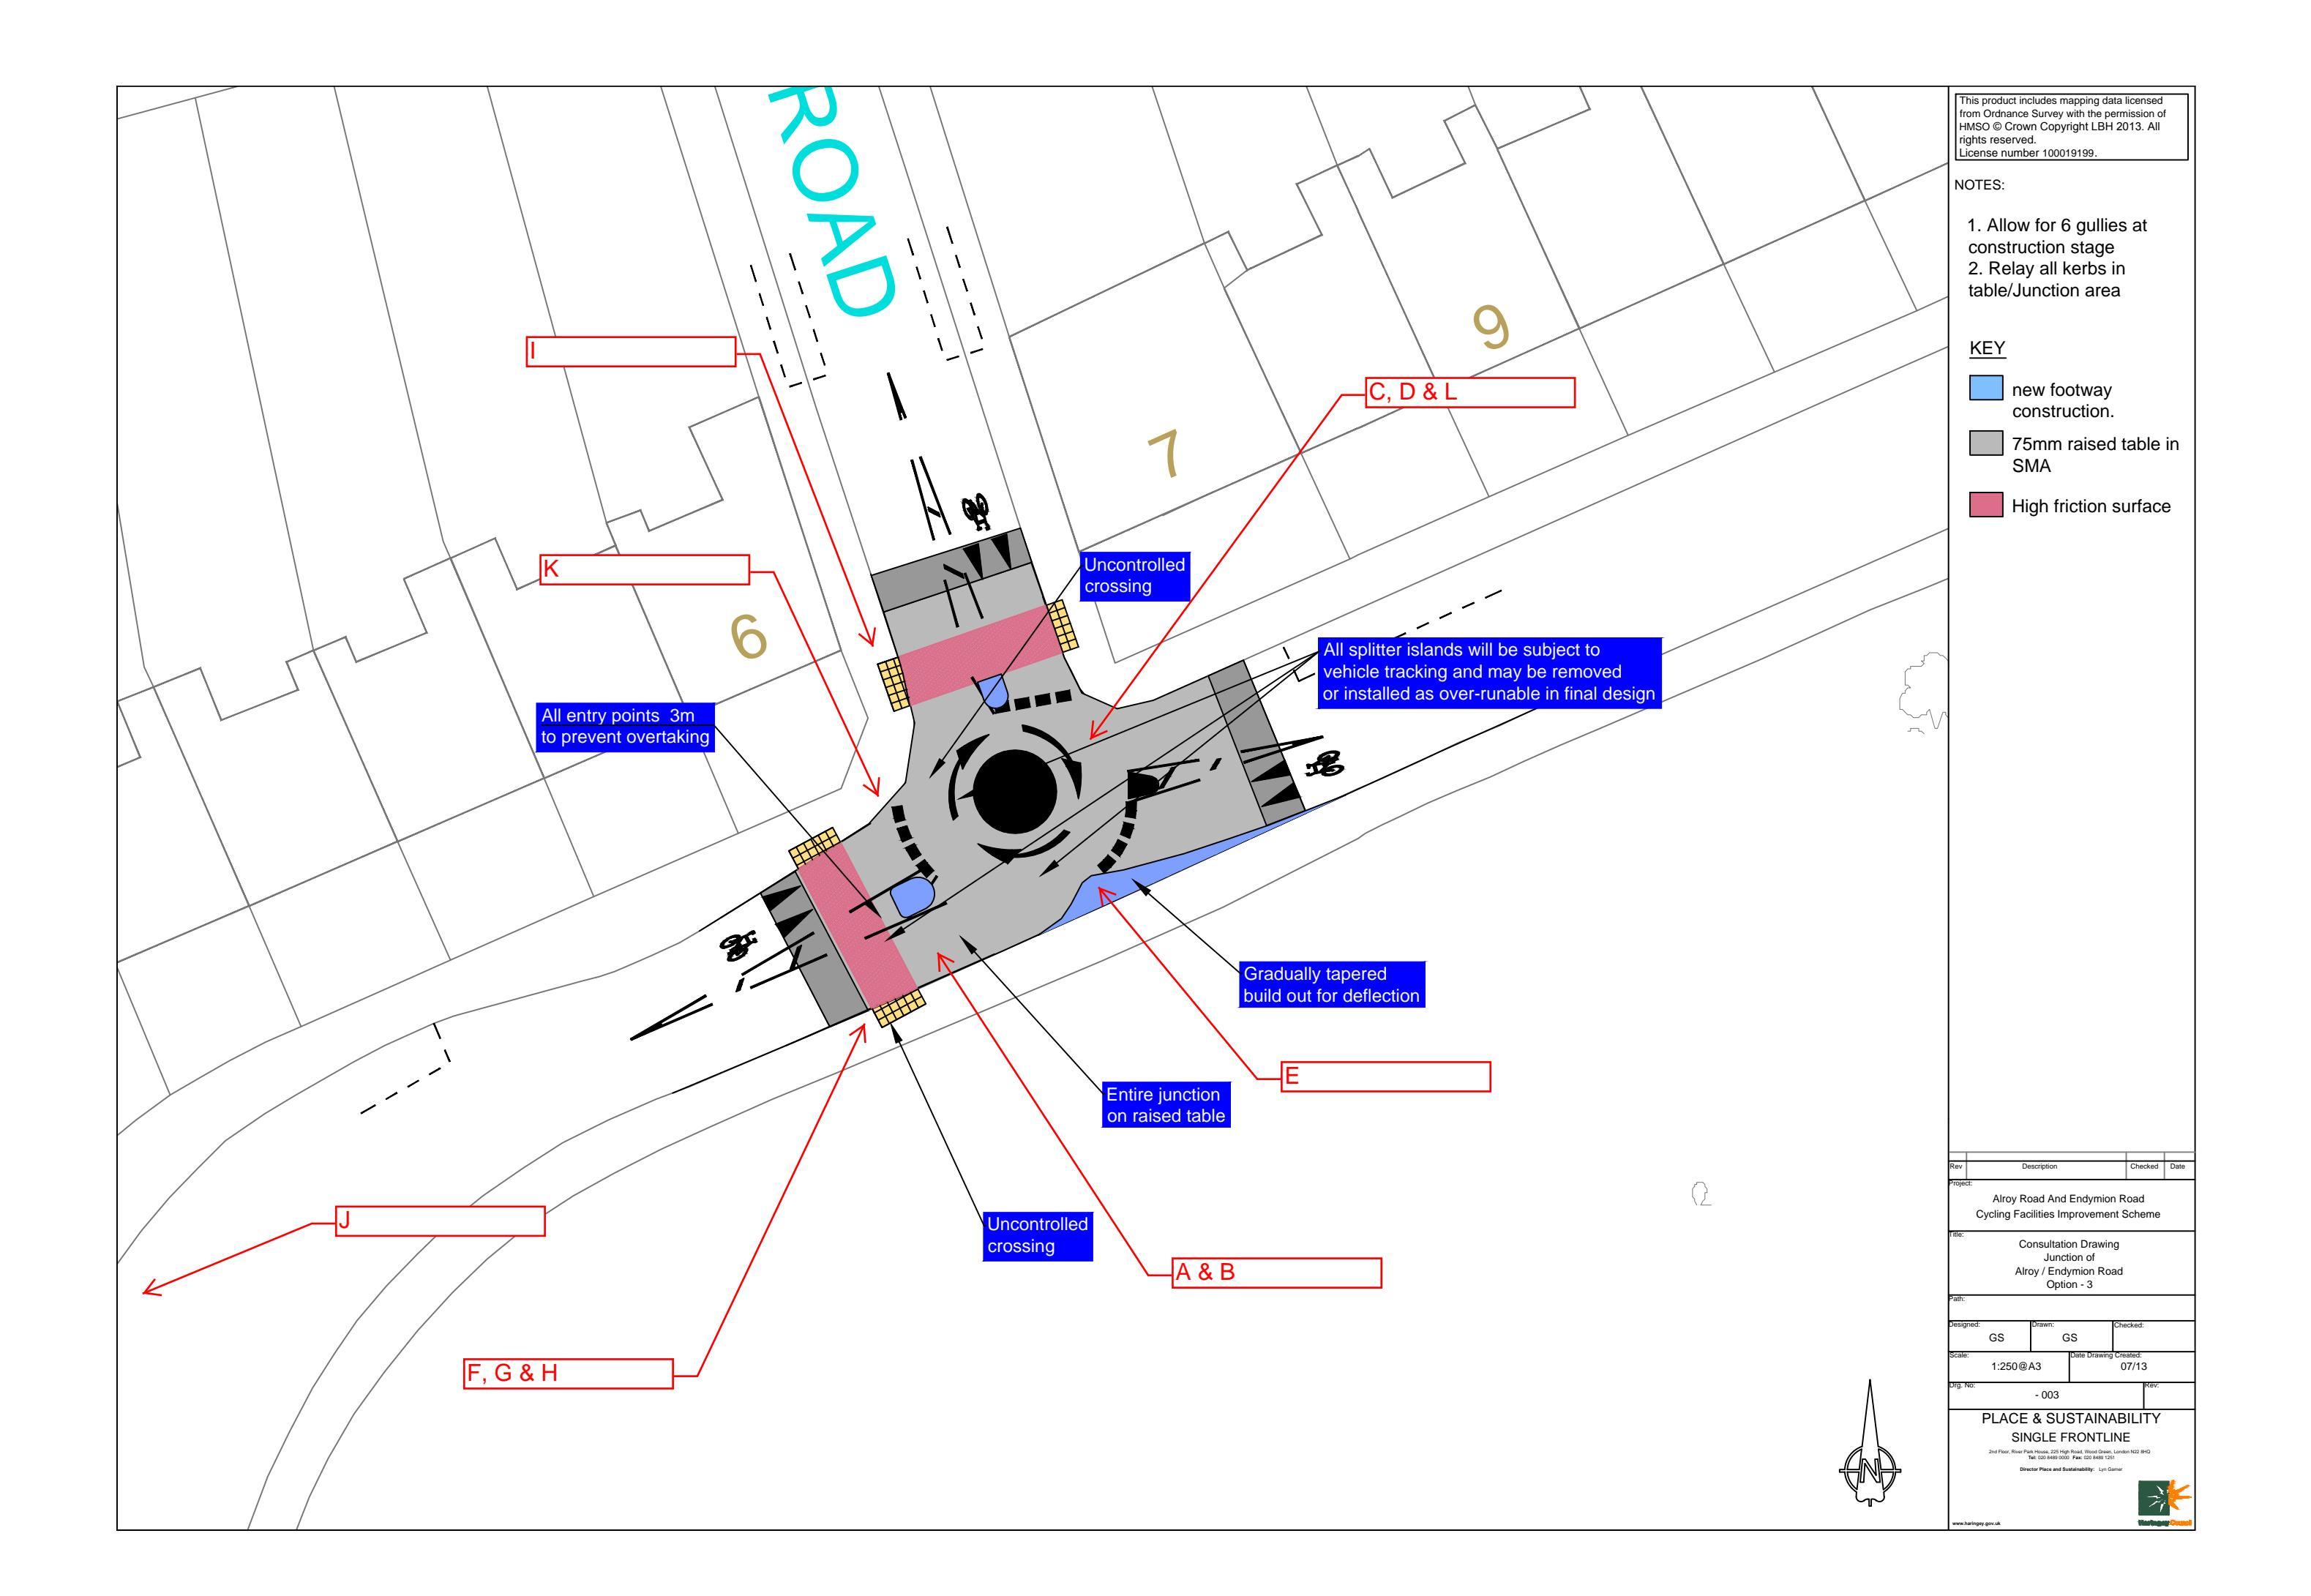
APPENDIX B - LOCATION DRAWING

Location A: Raised table - Drawing 003.

Detail: No construction details, including Polished Stone Values (PSV), of the raised table have been provided for assessment. Although, it is recognised that traffic speeds are likely to be lower, due the presence of the raised table, there will still be turning movements at this junction and as such it is likely that there will be a number of vehicle conflicts. If the surface course has a low PSV value then there is a risk of rear end shunt or side impact accidents.

Location B: Raised table - Drawing 003.

Detail: The proposals indicate that 6 gullies have been allowed to drain the carriageway; however, their positions are unknown. Insufficient drainage facilities at the base of the ramps and at the tapered buildout could lead to ponding, which would be detrimental to road safety and could lead to loss of control accidents.

Location C: Mini-roundabout - Drawing 003.

Detail: No construction details have been supplied for the splitter islands at the junction or the tapered buildout on the southwest bound approach to the junction. Inappropriate construction could compromise road safety.

Location D: Mini-roundabout - Drawing 003.

Detail: No swept paths at the junction have been provided for assessment and there is concern that vehicles, whilst negotiating a path around the traffic islands, may strike the kerb or overrun the footway, which could lead to loss of control or pedestrian accidents.

Location E: Mini-roundabout - Drawing 003.

Detail: No swept paths at the junction have been provided for assessment and the tapered build out will push southwest bound traffic further into the centre of the carriageway. In addition, it is proposed to have a traffic island on the southbound approach to the junction, which will restrict turning movements. During the site visit is was noted that under current conditions traffic turning left out of Alroy Road invariably over ran the parking bay on the northeastern side of the carriageway. There is concern that traffic turning left out of Alroy

Road may have head on collisions with waiting traffic; strike the kerb or overrun the footway, which could lead to loss of control or pedestrian accidents; or hit a parked vehicle.

Location F: Uncontrolled crossing on Endymion Road - Drawing 003.

Detail: During the site visit it was observed that traffic flows were constantly high on all arms of the junction, and that suitable gaps for pedestrians, particularly on Endymion Road were very infrequent. It is recognised that the introduction of a raised table will reduce traffic speed and that drivers approaching the junction may give way to pedestrians; however, there is concern that drivers exiting the junction will not be expecting pedestrian movements, which could lead to pedestrian or rear end shunt accidents.

Location G: Uncontrolled crossing on Endymion Road - Drawing 003.

Detail: On the southern side of the carriageway of Endymion Road, the visibility to the left at the proposed uncontrolled crossing is restricted by fencing and the left hand bend. In addition, traffic approaching the junction from the southwest approaches at an inappropriate speed and often crossed the centre line during the site visit. Restricted visibility and inappropriate speeds could lead to pedestrian or rear end shunt accidents.

Location H & I: Uncontrolled crossings - Drawing 003.

Detail: No details on dropped kerbs or the slope gradients have been provided for assessment. Dropped kerbs that are not flush or within a 6mm tolerance, could lead to pedestrian trip accidents; further excessive slopes, greater than 2.5%, are difficult to negotiate for many manual wheelchair users.

Location K: Mini-roundabout junction - Drawing 003.

Detail: Currently, there is no 'Mini-roundabout' signage on the northeast bound approach to the junction, nor is such a sign proposed as part of the works. Traffic on this approach is insufficiently warned that right turning traffic has priority at the junction, which could lead to side impact accidents, particularly during conditions of poor visibility when the road marking may be less visible.

Location L: Mini-roundabout junction - Drawing 003.

Detail: Currently, there is limited waiting available at the junction, which could lead to inappropriate parking, which could compromise road safety.

That the surface course of the raised table should have a PSV that is appropriate for the traffic speeds.

That care is taken to ensure that ponding does not occur, either by assessment of the carriageway profile (vertical and horizontal) or by drainage provision.

That the construction details of the splitter islands should be provided for assessment.

That swept paths should be checked to ensure that all expected vehicle movements can be safely accommodated.

That swept paths should be checked to ensure that all expected vehicle movements can be safely accommodated and that the length of the parking bay on the northeastern side of the carriageway should be reduced.

That the raised table should be extended and that a controlled crossing, type dependent on traffic flows, speeds and pedestrian movements, should be introduced on Endymion Road. Alternatively, that additional speed reducing features should be introduced on Endymion Road to provide suitable gaps for pedestrians.

That the height of the fencing should be reduced; centre hatching should be introduced on the northeast bound approach to the junction; and that the problem should be read in conjunction with item 2.4.1.

That the dropped kerbs should be flush with a 6mm tolerance.

That a 'Mini-roundabout' sign to diagram 611.1 should be installed at the junction for northeast bound traffic.

That at 'At Any Time' waiting restrictions should be installed at the junction.
