The Stability of the Victorian Clay Railway Embankment in Grange Park, London N21

The Effects of Tree Felling and Vegetation Removal

**By Peter Johns
On Behalf of The N21 Rail Action Group**

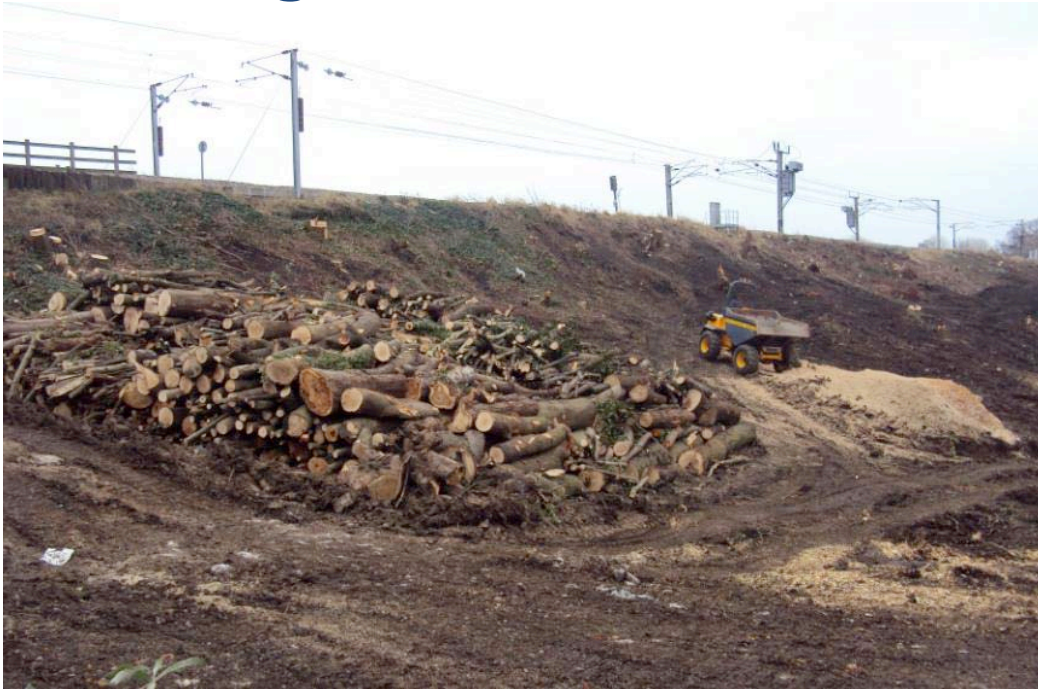
Figure 1

The railway embankments found in Grange Park were formed by end tipping hand excavated clay spits or clods (a spit is an undisturbed lump of clay cut by a small spade used in this type of excavation) and compacted using those resources available in late Victorian times. The result was an embankment that was not very well compacted. (fig.1)
